PROTECTING VILLAGE WATER SUPPLY IN YUNNAN

PILOT REMEDIATION OF ARSENIC MINING AREAS

SEPTEMBER 2009

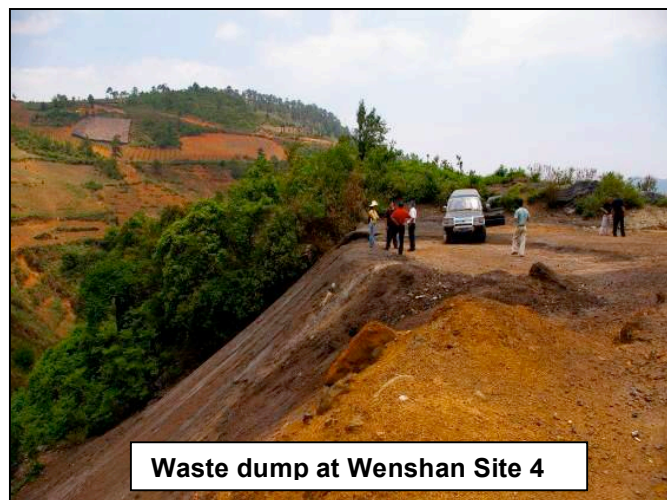
Surface water drainage samples were taken by Wenshan County EPB, at the request of Blacksmith, to provide a baseline level against which the post-remediation contamination could be compared. The reported arsenic concentration in the drainage from the sites was 1.07mg/L, 21.4 times above the limit (0.05mg/L).

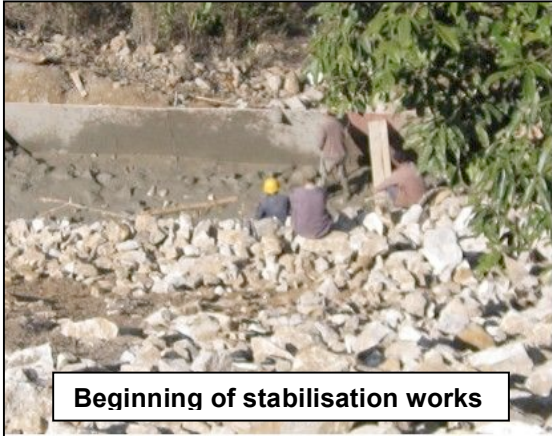
The main components of the works as completed were the construction of a retaining wall to create a stable tailings storage area and the installation of an impermeable lining to the area. The main arsenic residues were then moved to this area and placed in compacted layers to ensure stability. The surface of the completed storage area was then vegetated, using local species which are suited

to the conditions. Drainage ditches were installed along the sides of the final storage area to divert away the surface water flows.

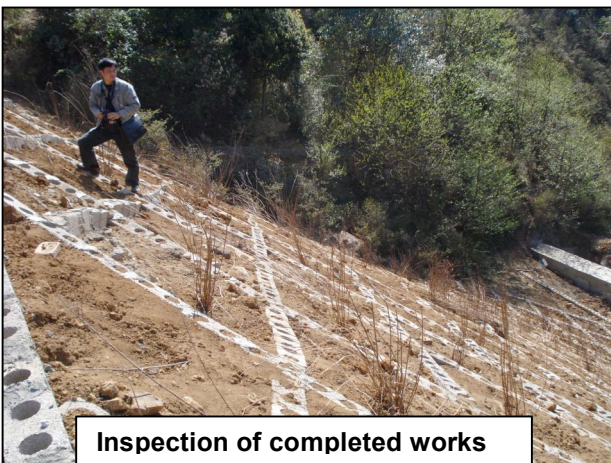
Inspection of completed works

In general, the field inspection confirmed that the main works have been completed as planned, although some areas that remain unfinished

were identified by the YEDI technical expert. The minor works required to bring the site up to the intended standard were discussed and agreed with Wenshan county and have now been completed.

The waste rock heap which had been eroding and releasing contaminated material in every storm has now been stabilised and surfaced. Drainage on the site has also been upgraded, which will divert stormwater away from the area of contaminated material. Therefore the major physical remediation objectives have been met.
